REUSING A LOG-BARRIER EMBANKMENT AT THE SUOMENLINNA SEA FORTRESS ISLANDS

MINNA LEINO

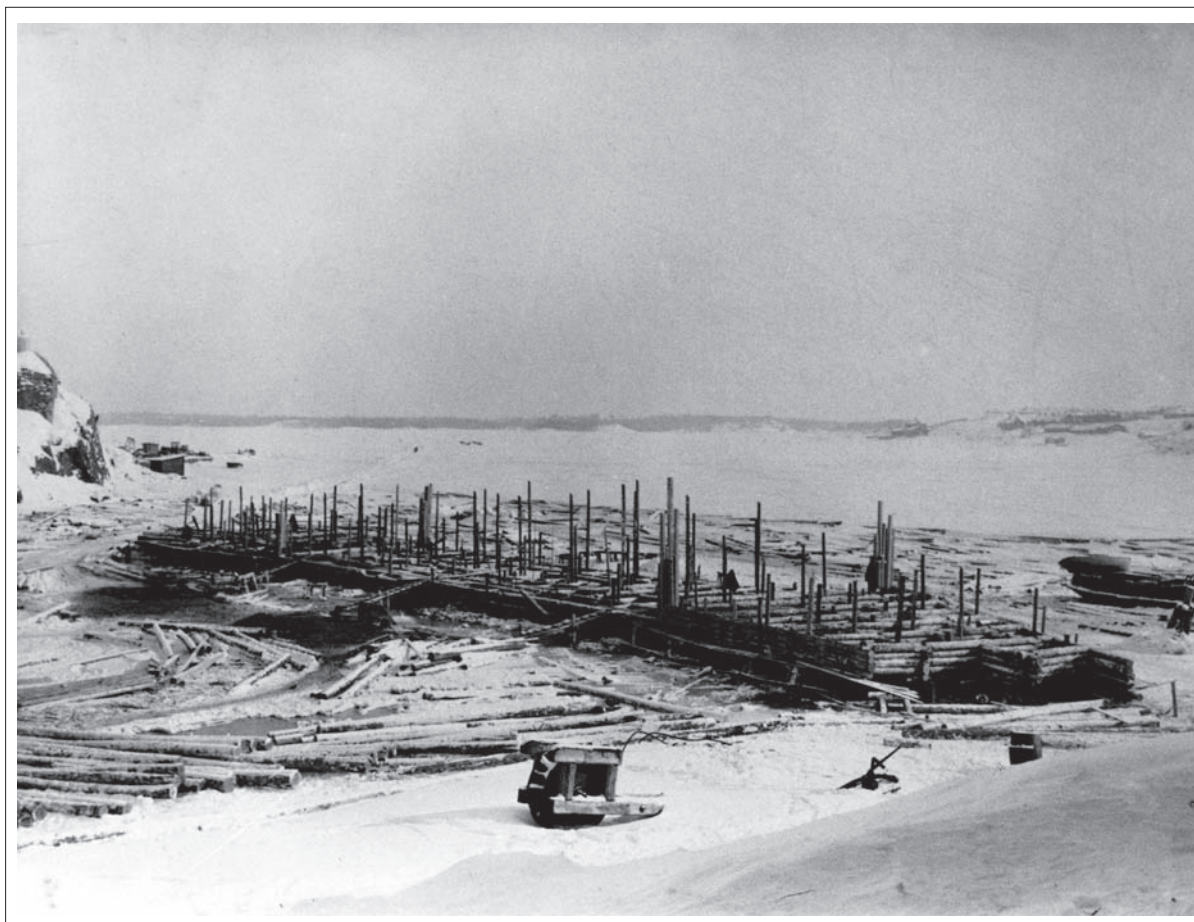
Fig. 1. The larger log-barrier embankment under construction, 17 February 1917, at the mouth of Tykistölahti Bay (Helsinki City Museum).

The larger embankment is submerged and invisible from the surface. It was identified by the marine archaeologist Harry Alopæus in an article in 1984. He had found the only 'eyewitness' to the construction work, which had so far been referred to as only an unfinished plan without any kind of building activity. This eyewitness is an old photograph from the archives of the Helsinki City Museum, dating from 17 February 1917 (Fig. 1). In this picture, the larger log-barrier embankment is partly floating on top of the current location, giving us an excellent dating for the construction work (Alopæus 1984, p.34).

We could not reach a more precise dating for the structure. We have a dating for the construction already from a previously mentioned old photograph, where the construction is visible in the year 1917. It was taken in the spring of 1917. In this sense, the dendrochronological samples do not give us new information for dating the construction.

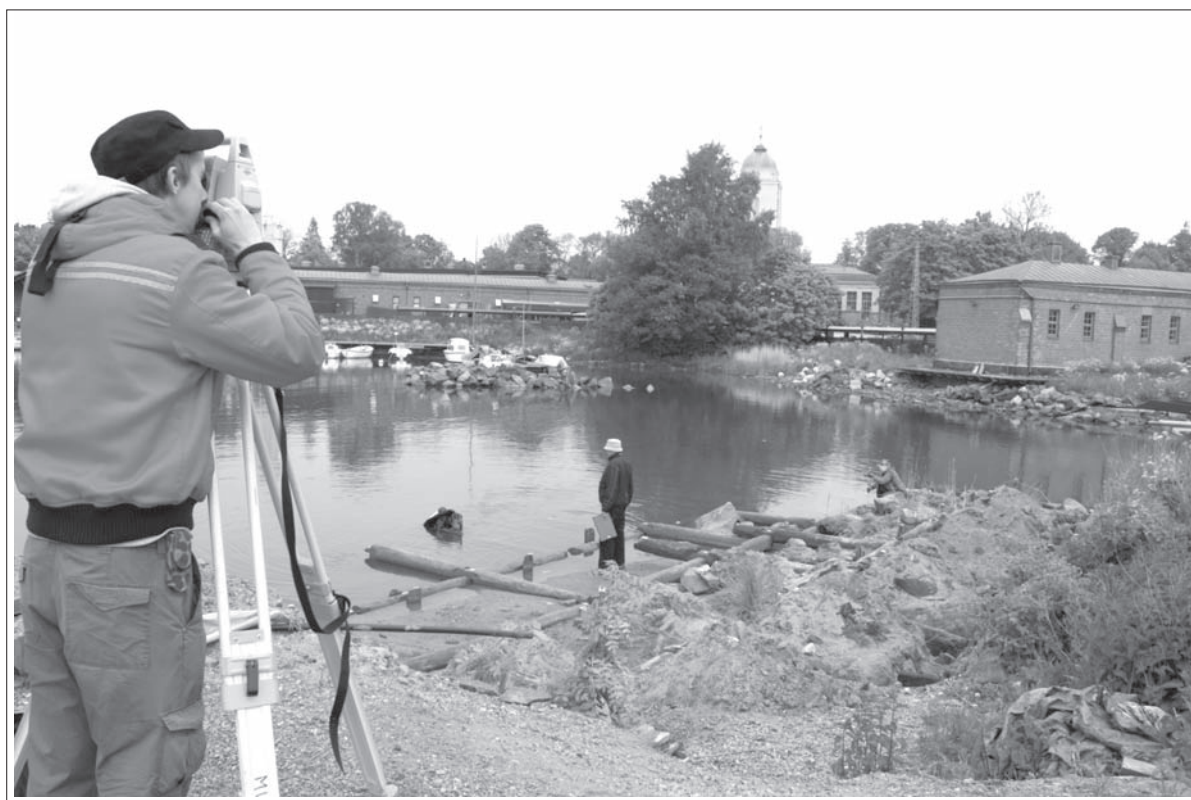
Fig. 5. Archaeological documentation on the smaller log-barrier embankment was carried out with the help of Total Station (photograph by M. Leino).

Archaeological documentation was carried out on this structure from 8 to 12 June 2009, covering altogether 160 square metres. The construction of the log-barrier embankment was first excavated with shovels. The underwater part of the construction, mainly the end and the side profiles, was brushed and cleaned of vegetation and sediment. The whole construction was documented by photographing it with digital cameras. The construction was documented in detail with Total Station (Fig. 5). The side profiles were only visible in the underwater parts, and were thus in addition measured and drawn by hand. These two sets of information were combined afterwards. In the documentation, the focus was on different kinds of joints and the condition of the wooden material (Fig. 6).
