# A DEFENCE INSTALLATION OF THE DEVELOPING LITHUANIAN STATE

ALGIRDAS GIRININKAS

The Rėkučiai defence installation is in the eastern part of Lithuania between two lakes in wooded country. The installation was comprised of a rampart and a ditch in front of it. This defence installation from the 12th and 13th centuries belongs to the most important fortified area of the newly developing Lithuanian state. It extended about 50 kilometres from east to west, and was built as a defence against the Polotsk-Pskov duchies and the Livonian Order. Analogous defence installations include Kovirke (“Cow Wall”), a lesser fortification within the well-known Dannevirke earthwork fortification complex, as well as the ramparts left by Prussian tribes.

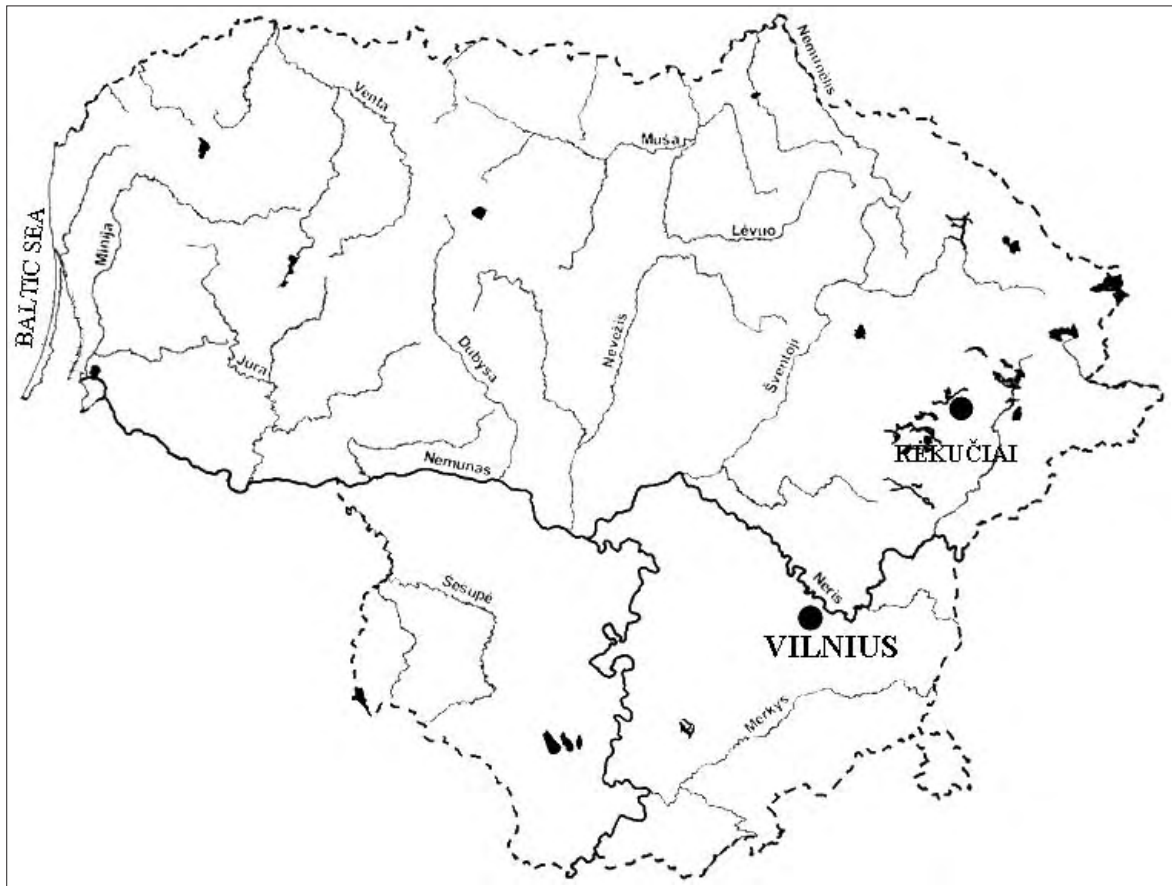
Fig. 1. Situation plan of the Rėkučiai defensive fortification.

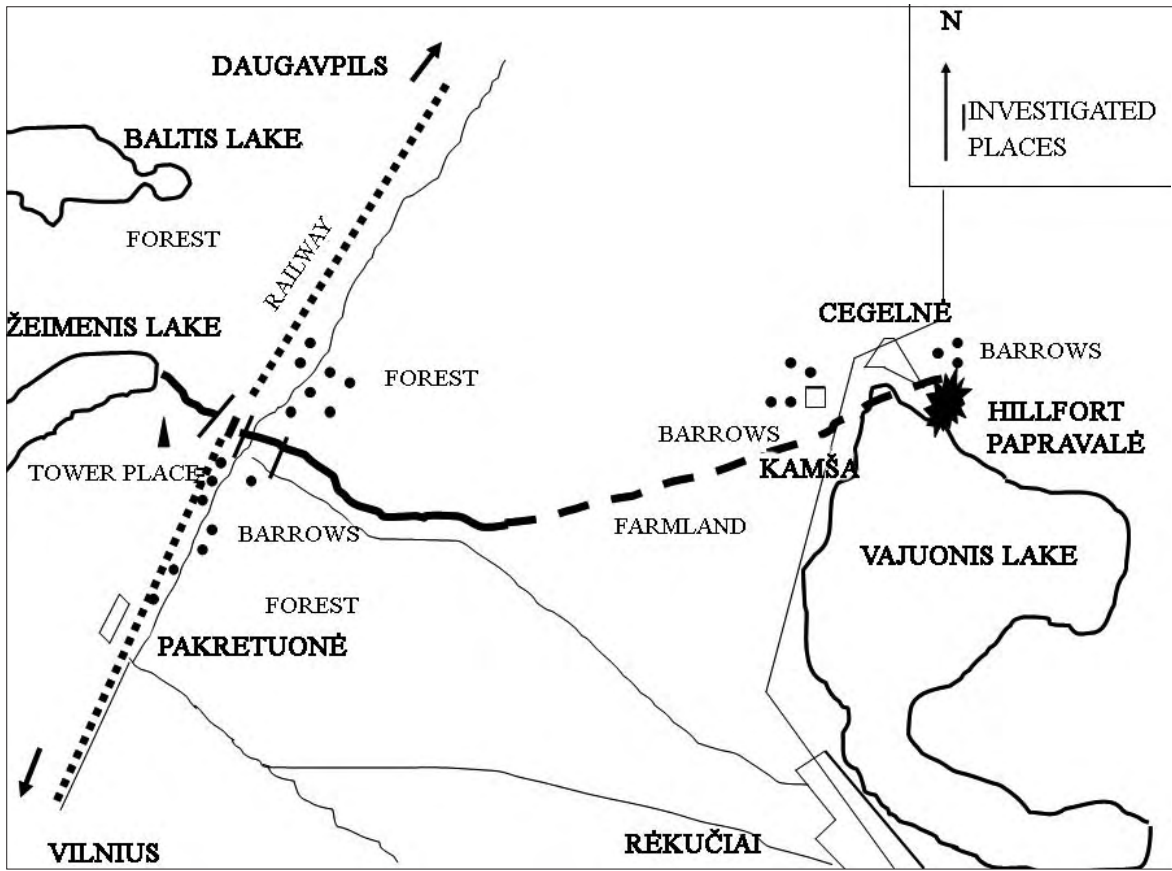
Fig. 2. Plan of the Rėkučiai defence installation.

The Rėkučiai defence installation is in the Švenčionys district of the Švenčionėliai area, in the Pakretuonė forest, between Lake Žeimenis and Lake Vajuonis (Fig. 2; Plate VII: 3). It consists of a rampart and an adjacent ditch on its northern end; this indicates that the enemy had to attack from the north or northeast. The defence installation extends in a southeasterly direction from a bay of the eastern shore of Lake Žeimenis to the Vilnius-Daugpilis railroad. Approximately 60 metres of the installation's length was dug out while building the railroad in 1859–1862. From the railroad, the defence installation runs first along the left and then along the right bank of a rivulet, along the Pakretuonė forest, and turns slightly to the northeast before terminating in the ploughed fields of the village of Rėkučiai. Having fallen in stretches of cultivated land throughout the ages, at this point the defence installation has flattened out. Survey work confirmed that its eastern part lies in tilled fields. It must have extended in a northeasterly direction up to the western or northwestern shore of Lake Vajuonis, where the well-fortified Papravale hill-fort was used for defence at the time. The top of the defence installation's absolute height from sea level ranges from 148 to 165 metres (Fig. 3).

fence installation in 1990, 1991 and 1994 (Figs. 2, 4). A better preserved 70-square-metre part of the defence installation, approximately 145 metres southeast of the railroad, was excavated in 1990. The width of the defence installation's excavated plot reached 11.3 metres. The rampart's width at the base reached 6.3 metres, its height one metre, the ditch's depth to the rampart's base was one metre, while its width was five metres. Upon removing the topsoil and sand, it became clear that underneath it was a frame-shaped construction notched together from pine timbers, while the up to 1.5-metre intervals formed in between them were filled with sand from the up to five-metre-high adjacent ditch that was on the northern side of the rampart (Fig. 5). This is how the bottom part of the rampart's framework was constructed. The diameter of the framework's timbers ranged from 14 to 20 centimetres. Remains of poles hammered vertically into the base on the outer side of the ditch were also discovered in the defence installation during the excavation. These poles must have comprised the overground part of the enclosure that had been on the northern end opposite the ditch and that were not preserved. Sharpened stakes up to 15 centimetres in diameter and 30 centimetres from the current ground surface were driven into the ground. Opposite the ditch, in a two-metre-long segment of the rampart's excavated area, two stakes were discovered pounded up to 35 centimetres deep into the soil. These stakes are presumed to have been an inherent constituent part of the entire defence installation. The ditch's slope from the rampart's side and a portion of the rampart were reinforced with 6×10×20 centimetre large rocks. It was established during the time of the excavation that the wooden framework part of the rampart had burned, since ashes, burnt-through timbers, and sand that had burnt to a red hue were discovered. Part of a field ploughed with a *žagre*-type plough (a wooden

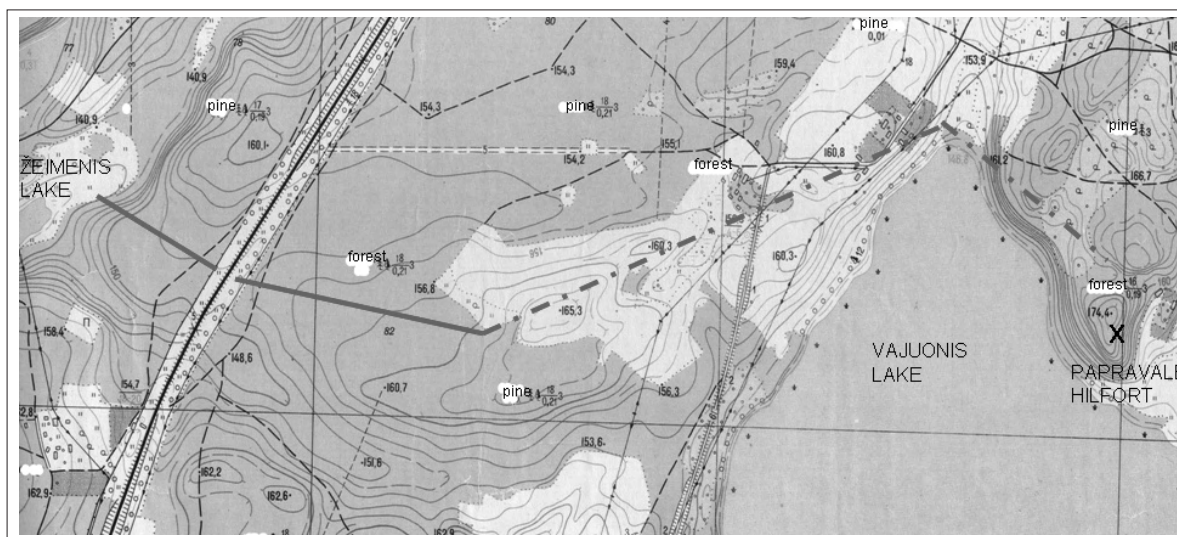
Fig. 3. Location of the Rėkučiai defence installation. Scale 1:10 000 cm.

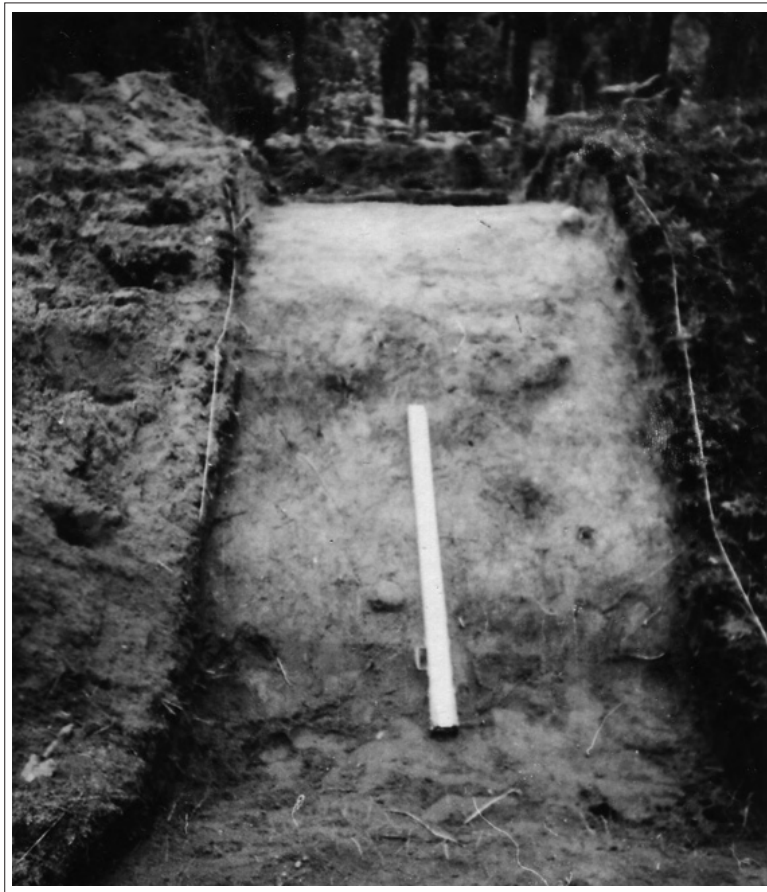
Fig. 4. The Rėkučiai defence installation's excavation in 1990. The rampart's slope reinforced with rocks (photograph by Girininkas).

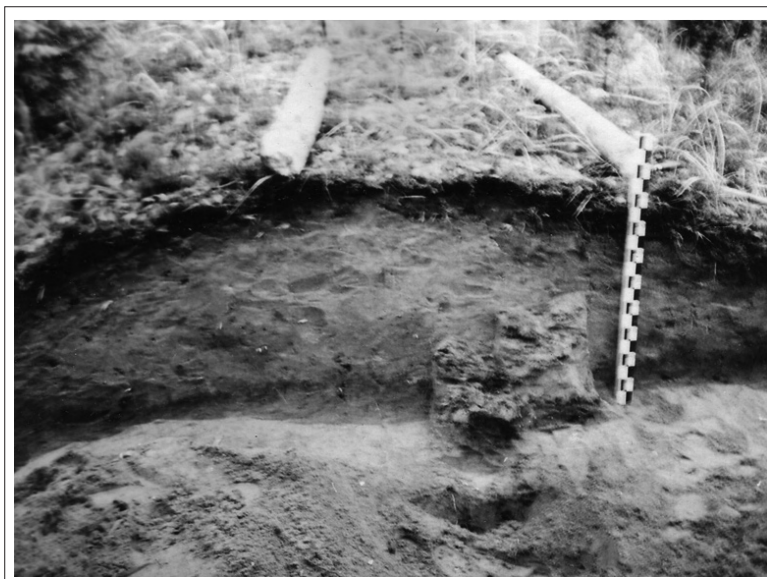
Fig. 5. The Rėkučiai defence installation's excavation in 1990: frameworks (photograph by Girininkas).

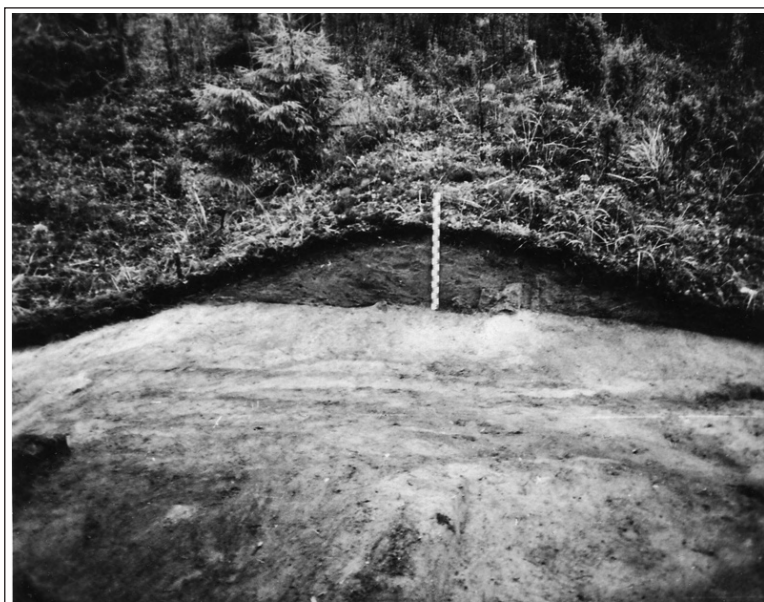
Fig. 6. The Rėkučiai defence installation's excavation in 1991: rows of timbers (photograph by Girininkas).

The most disturbed part of the rampart in a fire prevention strip east of the railroad was picked for excavation in 1991 (Figs. 6 and 7). Annually ploughed strips on both sides of the railroad damaged the defence installation. Just as in 1990, the excavation in 1991 uncovered part of an installed frame made of pine timbers. In some places of one section of the rampart, three frameworks, one on top of the other, were found jointed together, with wood charcoal and ash in the sand around them. Horizontally oriented timbers, piled one on top of the other in three rows, were found along the northern part of the rampart near the edge of the ditch (Fig. 5); these could have reinforced the rampart part of the construction from the northern side. A portion of the frames in the rampart had rotted rather than burnt through. Split and not split rocks 5×8×10 centimetres large were found on the rampart's northern slope from the ditch side. Just as in the first excavated plot, remains of sharpened, up to 20-centimetre-diameter timbers were found driven into the soil near the outer edge of the ditch and on its northern side.

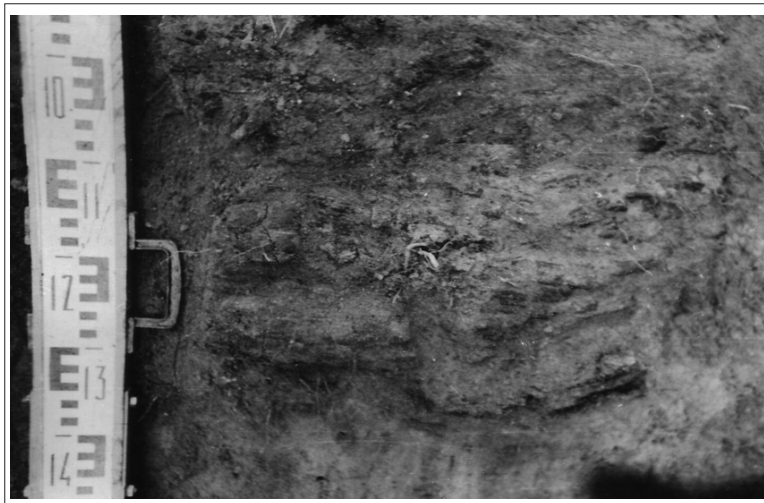
Fig. 7. The Rėkučiai defence installation's excavation in 1991: location of timbers (photograph by Girininkas).

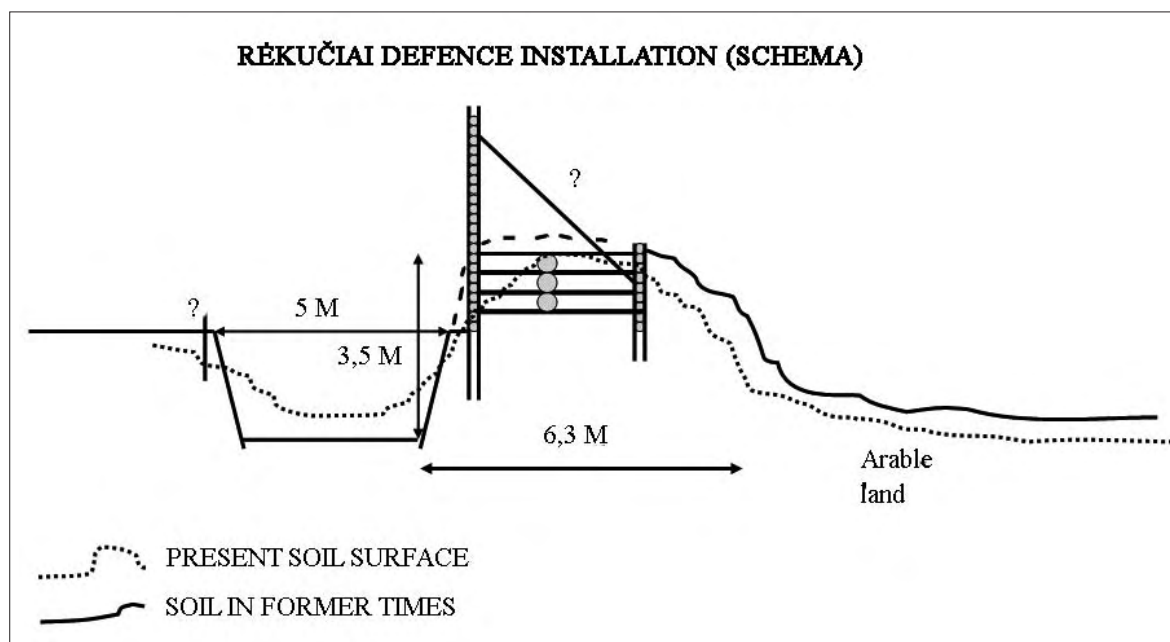
Fig. 8. A reconstruction of the Rėkučiai defence installation.

An effort to reconstruct this defence installation has been made based on the data of three years of excavation. It is believed that the first obstacle for an attacking enemy must have been the wooden enclosure opposite the ditch. According to the research data, it could not have been a solid timber wall, but rather a barrier consisting of every two to four metres vertically hammered wooden timbers and a short wall interwoven from larger poles or notched together from smaller timbers that was supported by the vertically hammered stakes (Fig. 8). This obstacle could not have been tall, so that the enemy could not hide behind it.

Behind this barrier was a 1.5 to two-metre-deep and up to five-metre-wide ditch. The ditch's bottom and the rampart's slope from the ditch side were reinforced with rocks.

Behind the ditch was the rampart. It was reinforced both longitudinally and transversely by up to 20-centimetre-diameter timbers that were notched together into a framework. The frame that reinforced the base of the rampart had three or more rows. The pine timber framework constructed in this fashion was strewn with sand that was probably dug out from the defence ditch as well as with rocks.

The notched framework's length and width reached 1.5 metres. Just like the Rėkučiai defensive rampart, the upper layers of the Įpiltis (Kretinga district), Apuolė (Skuodas district), Aukštadvaris (Trakai district) and Punia (Alytus district) hill-forts of the ninth to 12th centuries were also found equipped with ramparts (Puzinas 1938, pp.122-123; Daugudis 1982, pp.66-70). The height of the Rėkučiai defensive rampart could have reached 1.5 to two metres from the surface of the ground at that time. Data confirming whether or not a wall of vertically hammered or dug-in timbers stood on the rampart is so far scarce. Only the timbers longitudinally placed one on top of the other found on the rampart's northern side in the second plot could have been used for the reinforcement of the rampart's northern portion or the bottom portion of the small defensive wall on top of the rampart. Its existence would also be testified to by the two adjacent

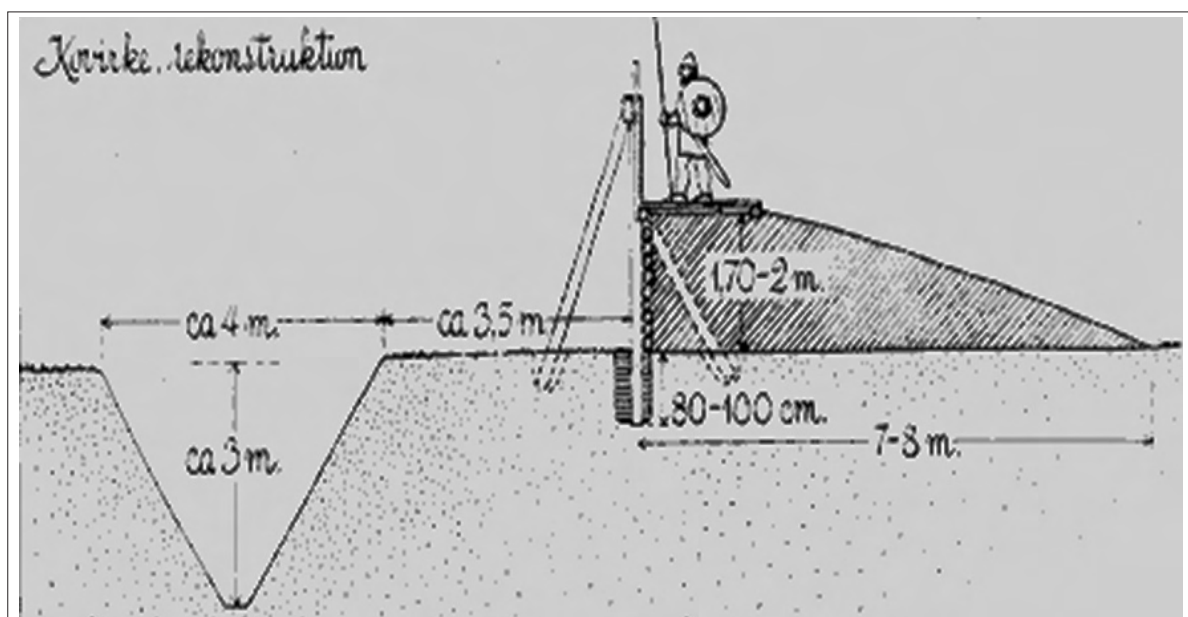
Fig. 9. The Kovirke (Cow Wall) defence installation.

Defensive installations analogous to that of Rėkučiai are known from the border of Germany and Denmark. There, the eighth-century defensive wall of Kovirke (Cow Wall), which is between the settlements of Selk and Kl. Rheide and south of Dennewerk (Andersen 1992, pp.18-21), was intended for battles with the Carolingians (Figs. 9 and 10). This fortification is very similar to the Rėkučiai fortification both in its structure and in its form. Only the Kovirke fortification is two metres wider and could have been one metre higher. Analogous defensive fortifications were left by the Prussian tribes. These were in the Curonian Isthmus at Krancu, Olendry, and other localities. Prussian lands were separated from each other by a so-called no man's land (wasteland). On both sides of the wasteland, the Prussians would establish systems of ramparts with wooden enclosures and small watchtowers. Often the wooden enclosures would be reinforced with earth and rocks (Okulicz-Kozaryn 1983, pp.207-213; Šneidreitas 1989, p.51f.).

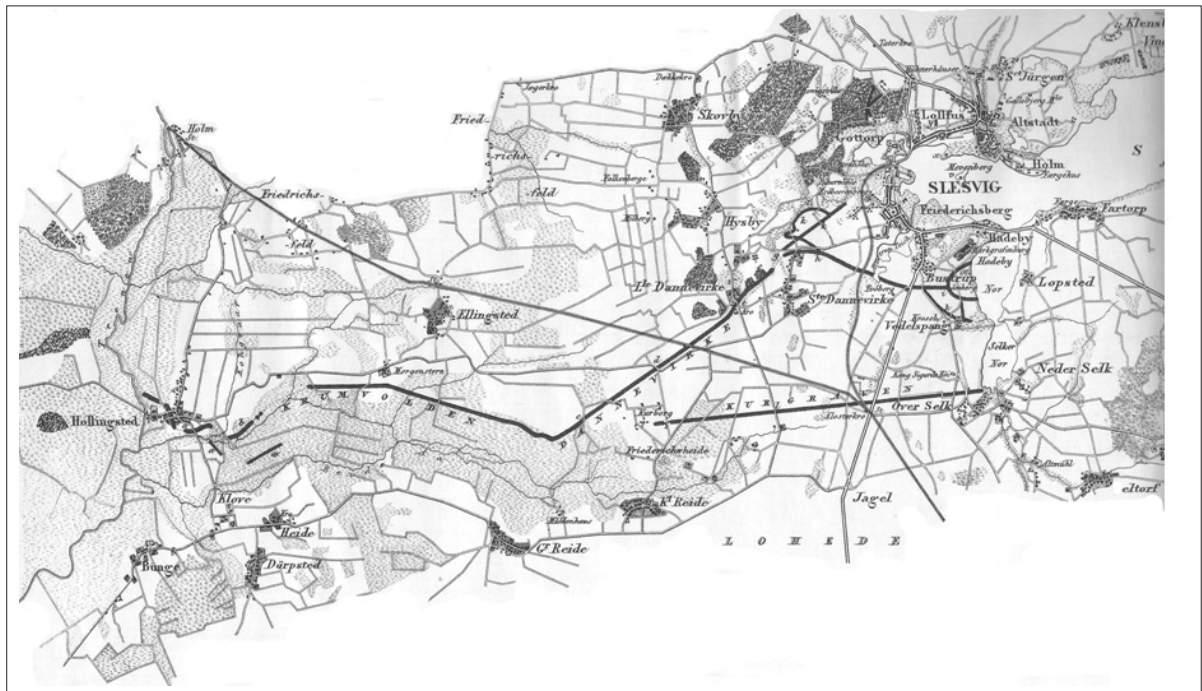
Fig. 10. The Dannevirke defence installation.

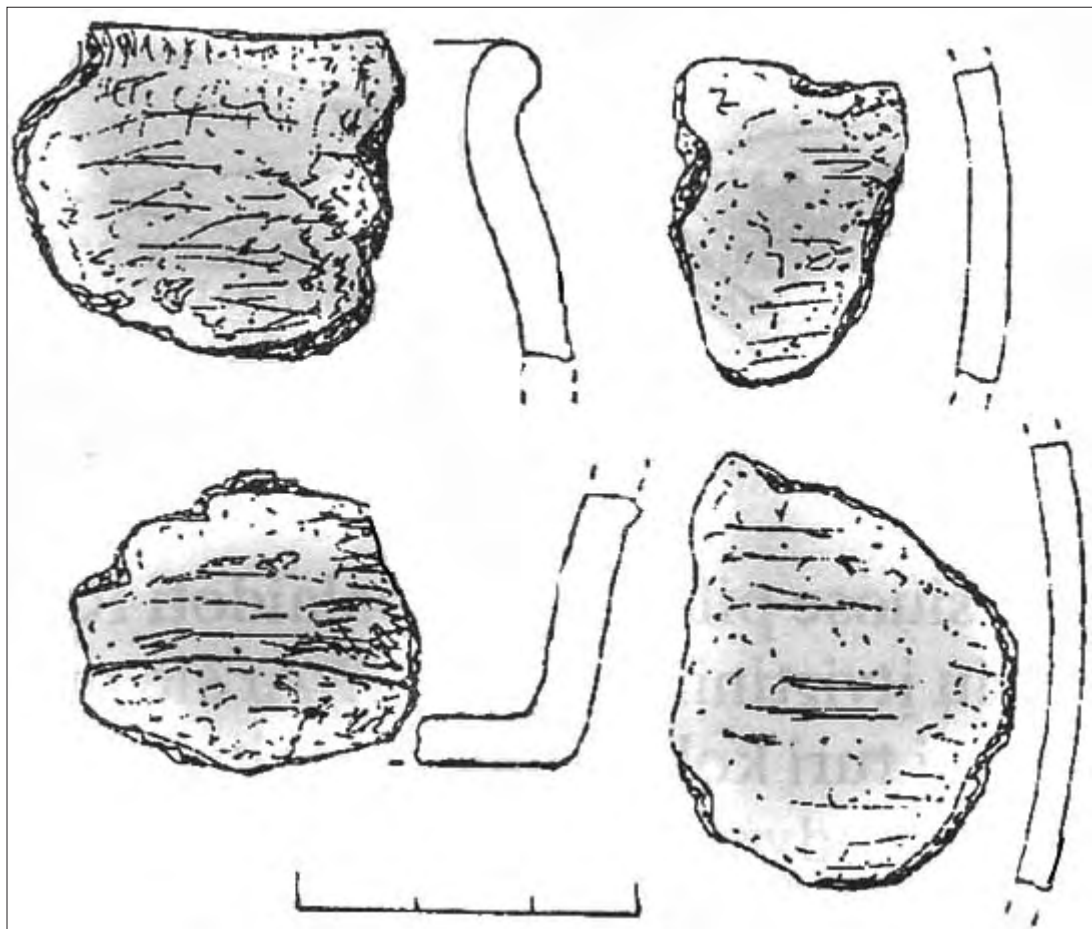
Fig. 11. Thrown pottery found in the top cultural layer of the Papravale hill-fort and in the Rekučiai "Gate" area.

and the defence installation is testified to by the contemporaneous wheel-made pottery, dated to the beginning of the second millennium AD, found both at the Papravālē hill-fort and at the “gate” locality (Fig. 11).

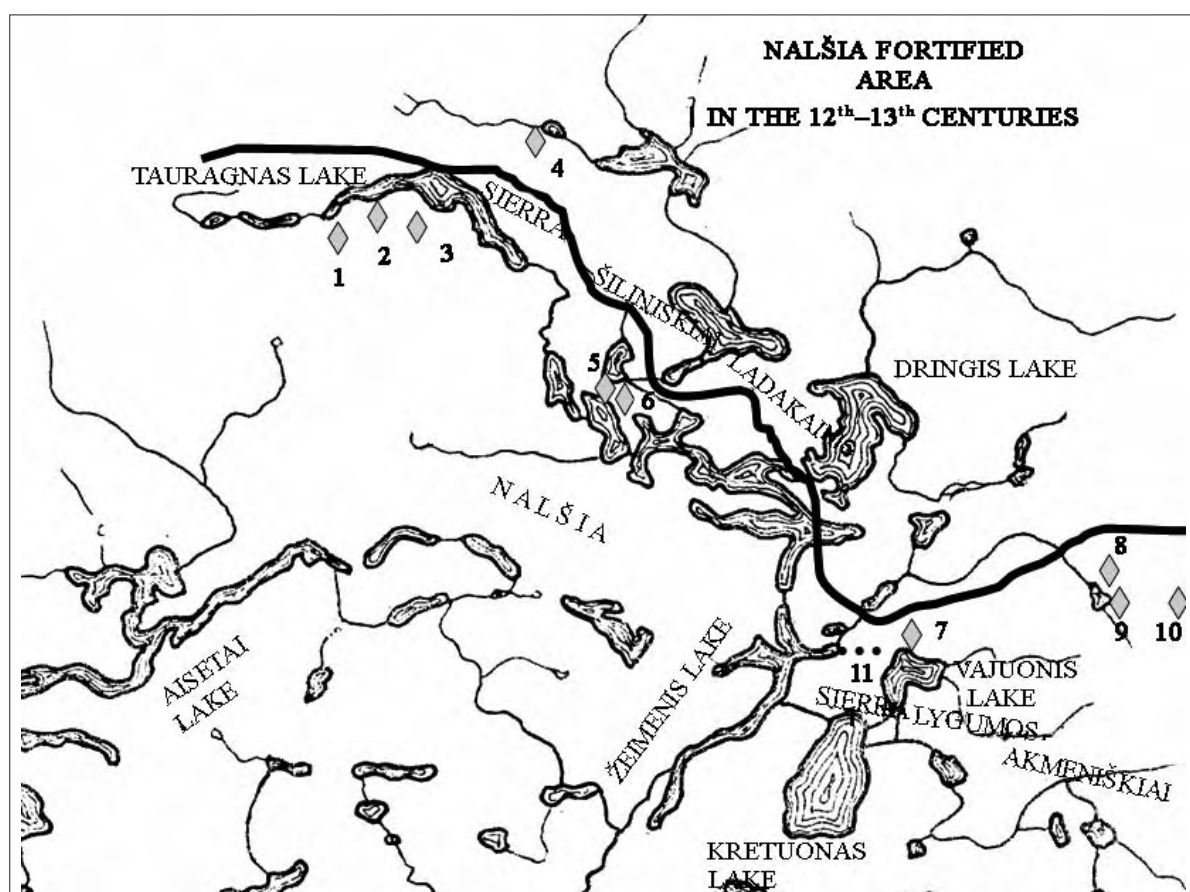
Fig. 12. The northern part of the Nalšia defence line: 1 Tauragnai hill-fort (1st mil. - beginning of 2nd mil.); 2 Taurapolis hill-fort (1st mil. - 15th cen.); 3 Sēla hill-fort (1st mil.); 4 Šeimatis hill-fort (1st mil. - beginning of 2nd mil.); 5 Papiliakalnē hill-fort (1st mil.); 6 Ginučiai hill-fort (first half of 2nd mil.); 7 Papravālē hill-fort (1st mil. - beginning of 2nd mil.); 8 Velioniai hill-fort (1st mil.); 9 Mažulonys hill-fort (1st mil. - 13th cen.); 10 Strakšiškē hill-fort (1st mil.); 11 Rēkučiai defence line (end of 12th - beginning of 13th cen.); 12 the estimated defence line of the northern part of Nalšia (end of 12th - beginning of 13th c.).

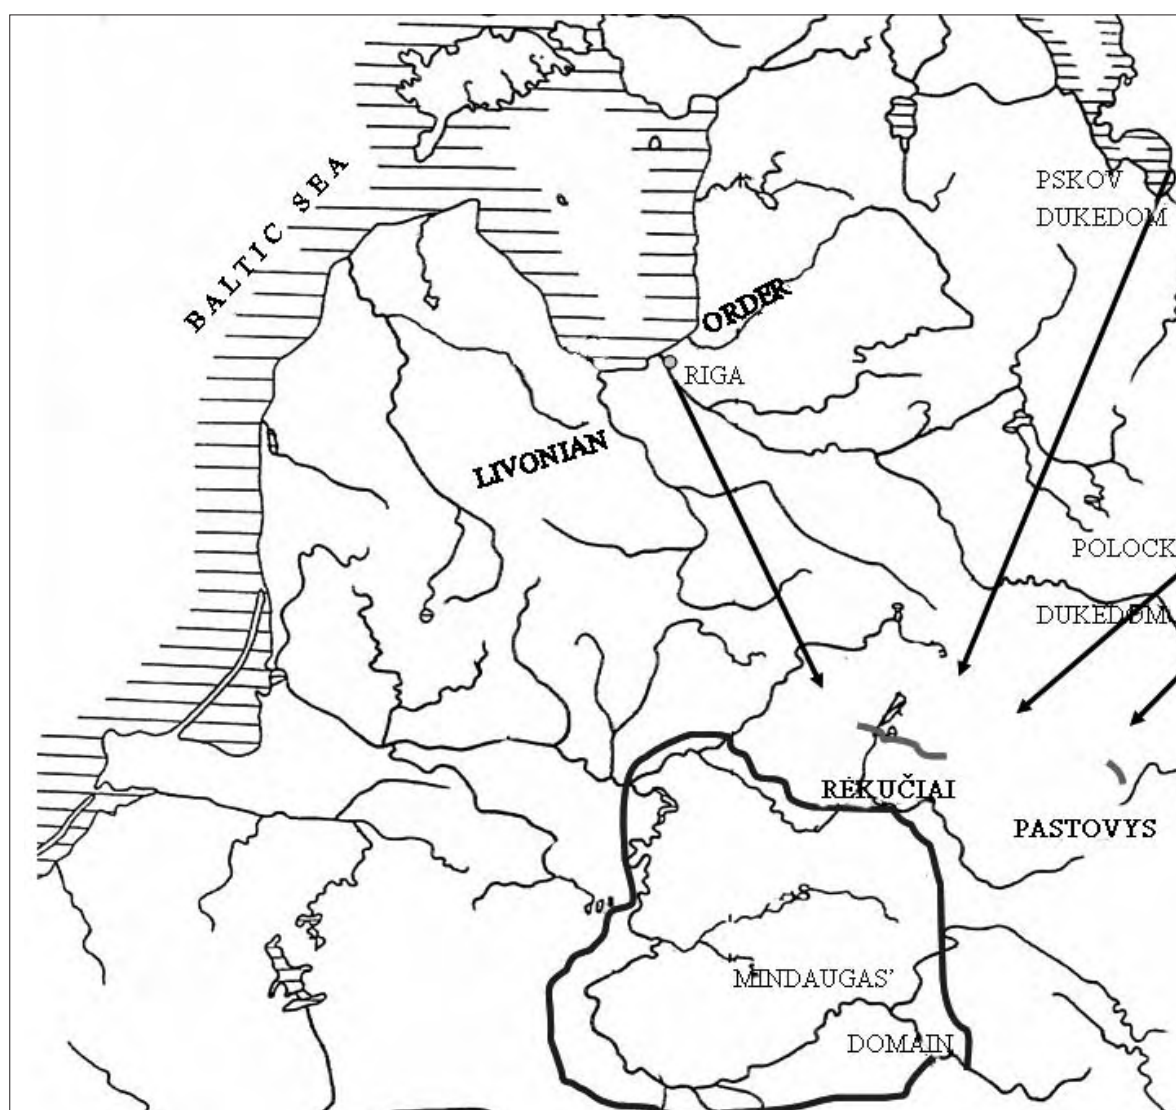
Fig. 13. Nalšia's defence at the beginning of the 13th century.

The number of Lithuanian enemies from the northeast and north increased at the beginning of the 13th century. First, the Livonian Order consolidated near the River Daugava in this period, and the Russian duchies of Polotsk and Pskov spread their influence. Lithuanians, the inhabitants of Nalšia, began to attack intensively the area along the Daugava at the beginning of the 13th century (Baranauskas 2000, pp.172-180; Gudavičius 1989, pp.30-35). Perhaps in fear of retaliatory attacks, they strengthened their defence line, into which the Rėkučiai defence installation fell (Fig. 13).
